BMSU Radiometric Systems and Applications

Presentation

Bauman Moscow State University

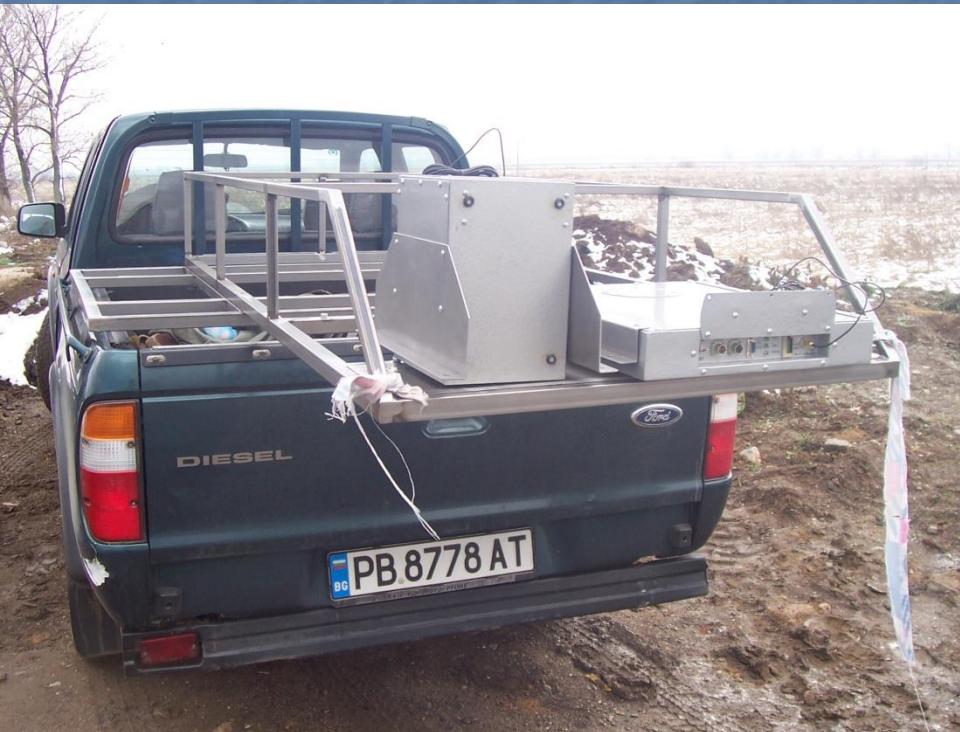
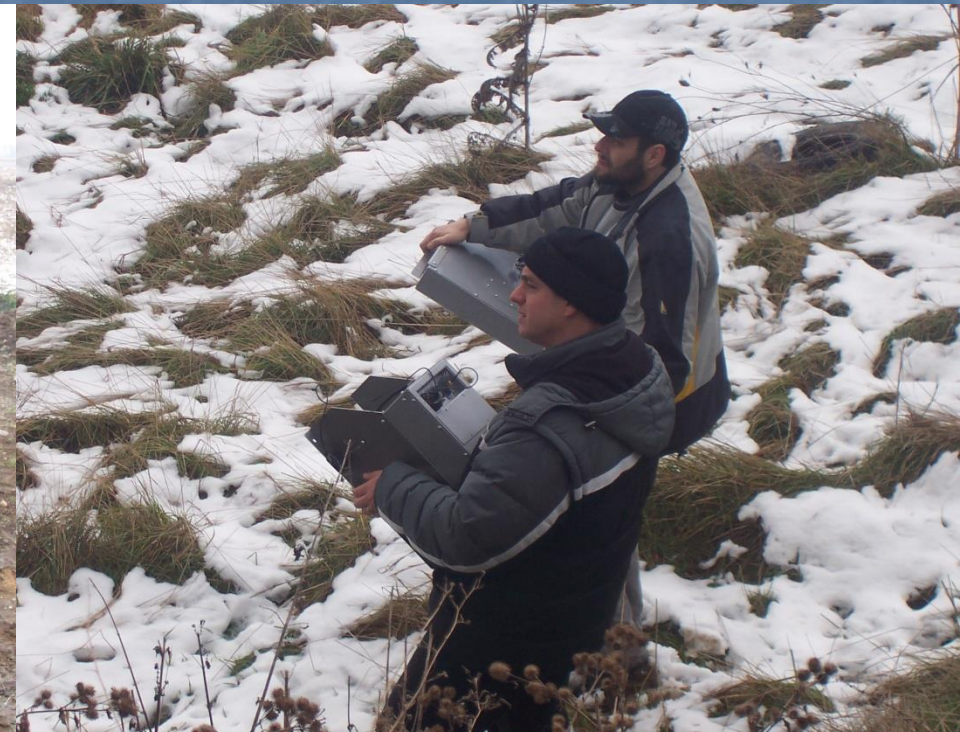
"Mirage" series of portable radiometers

Full-scale tests. Bulgaria 2008

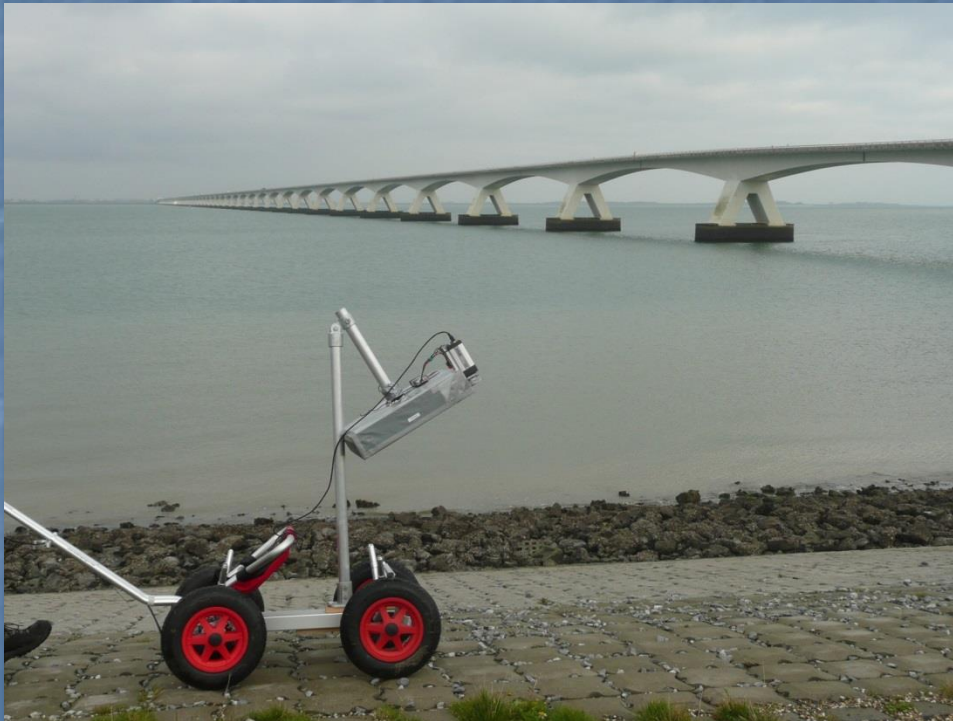
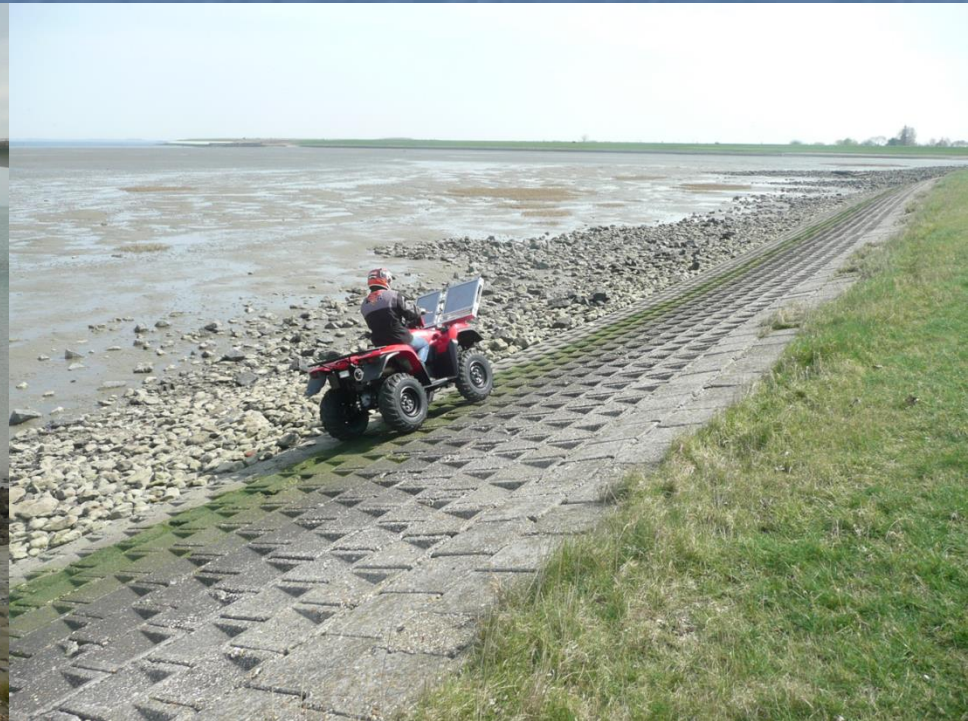
Dam condition monitoring «Mirage-21» equipment (The Netherlands)

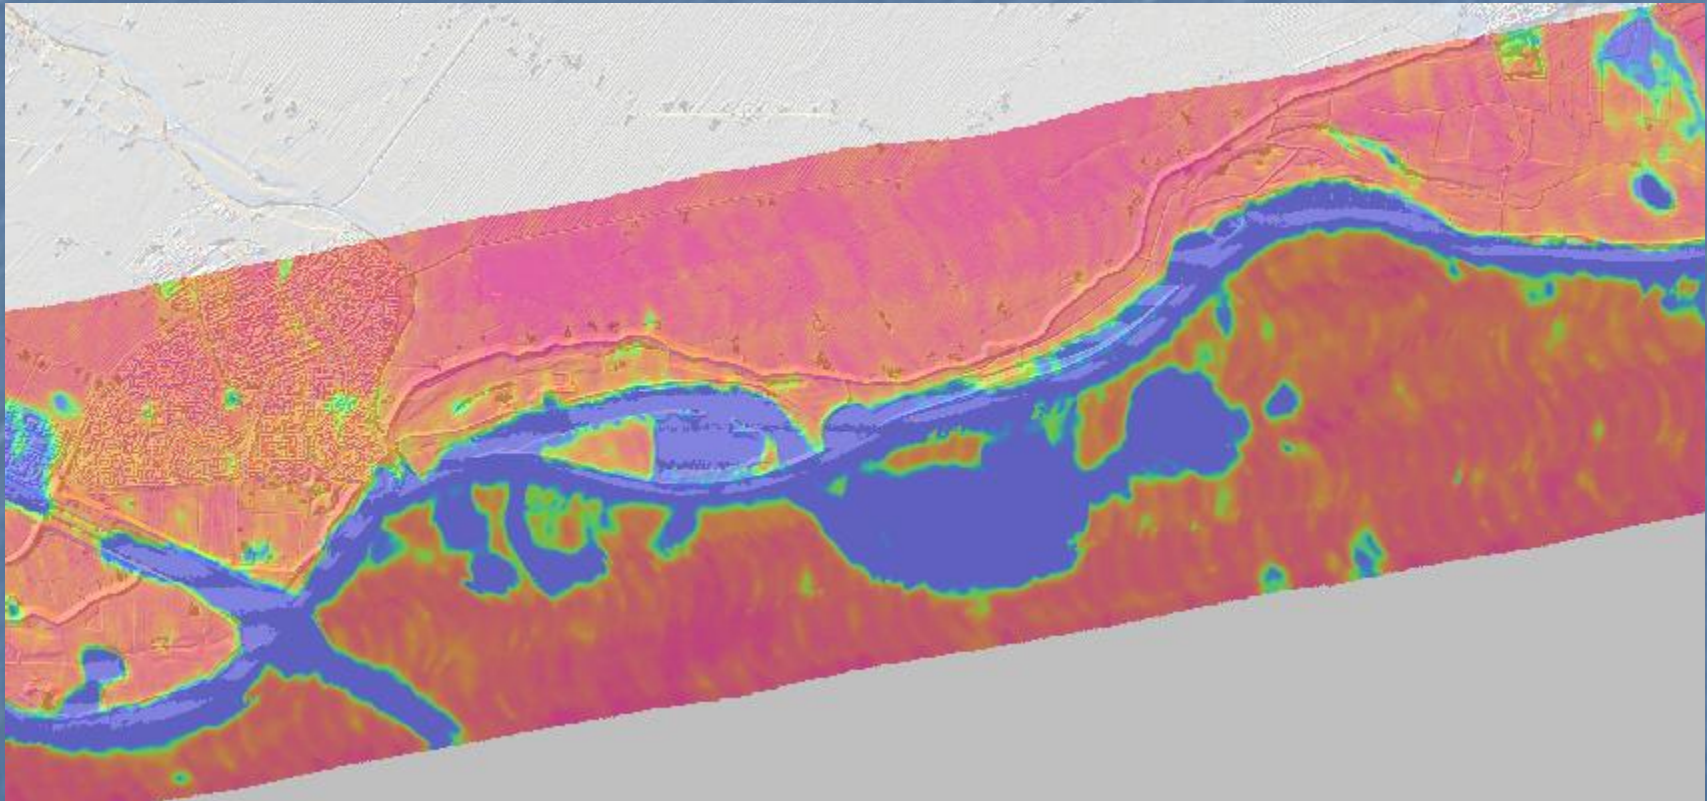
The Netherlands, underground leaks in earthen dams

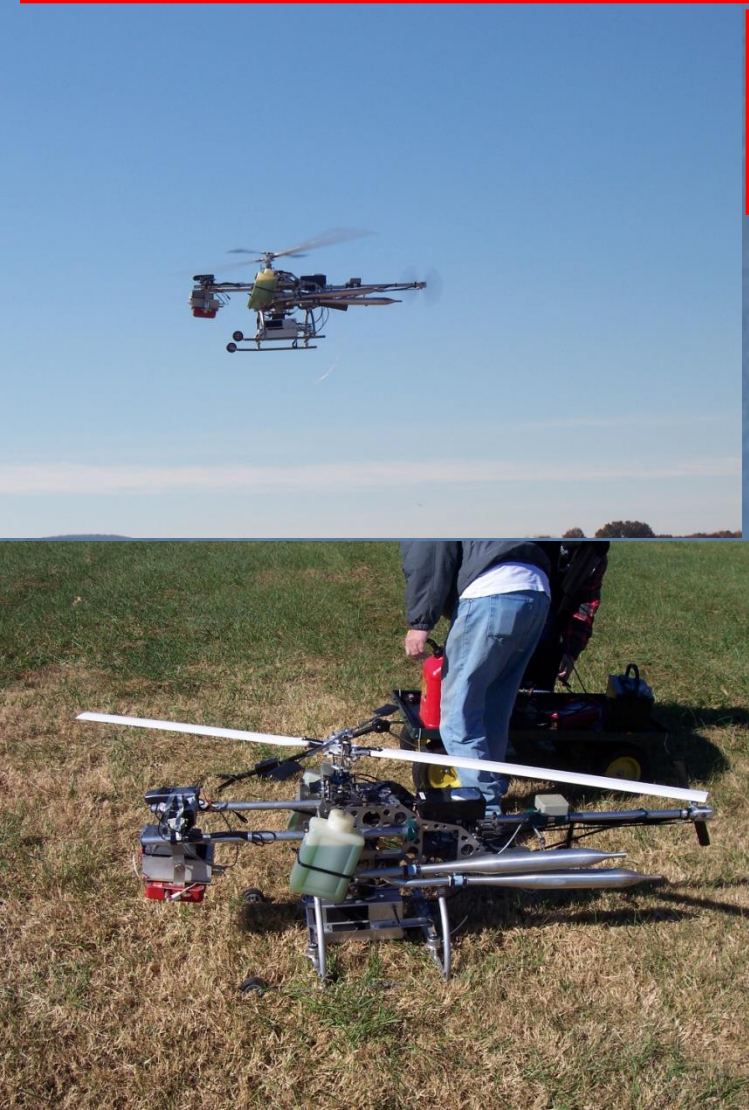
Radiometer on an unmanned helicopter with AAMU and NASA (USA) support

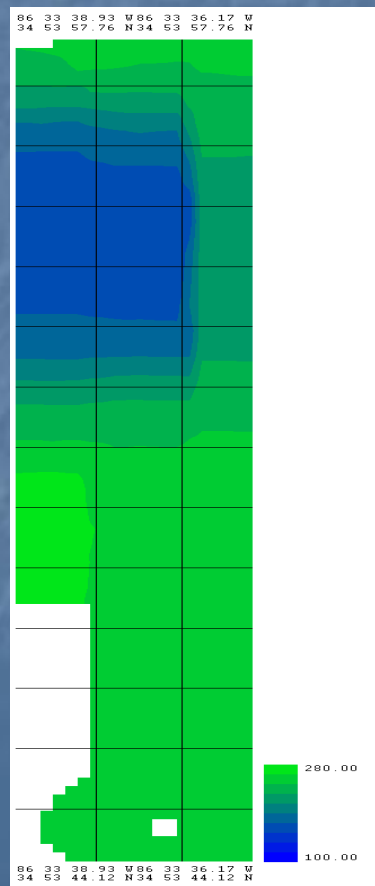
Brightness map

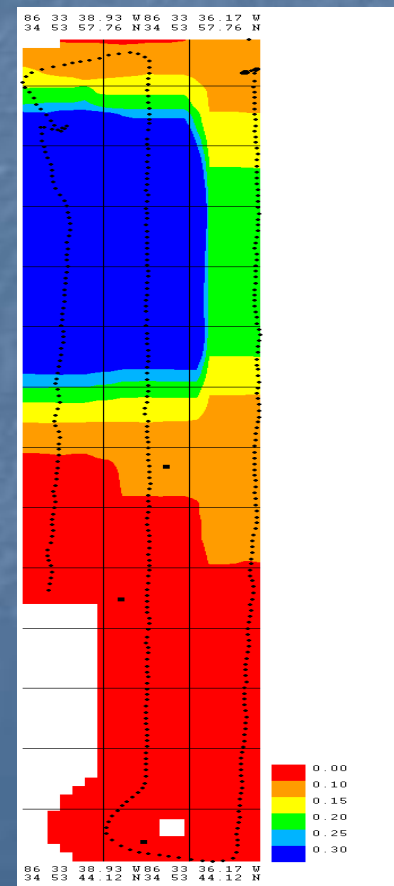
Moisture map

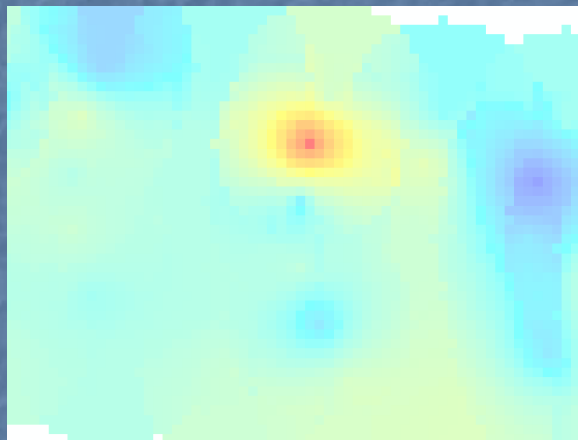
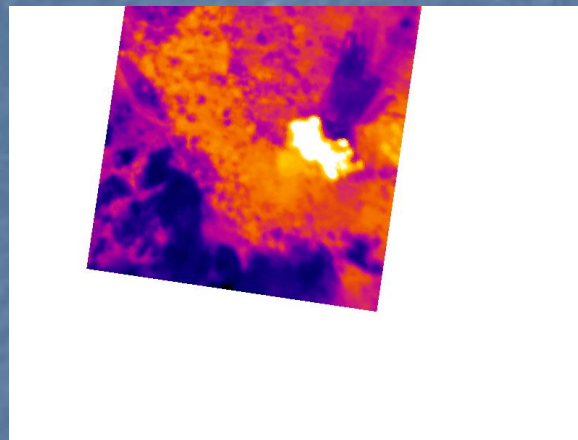
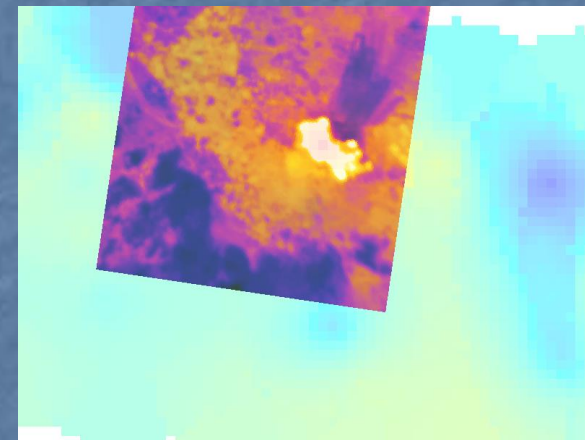
The focus of a forest fire is the data of a microwave radiometer of 5 cm. in comparison with the data of a thermal camera

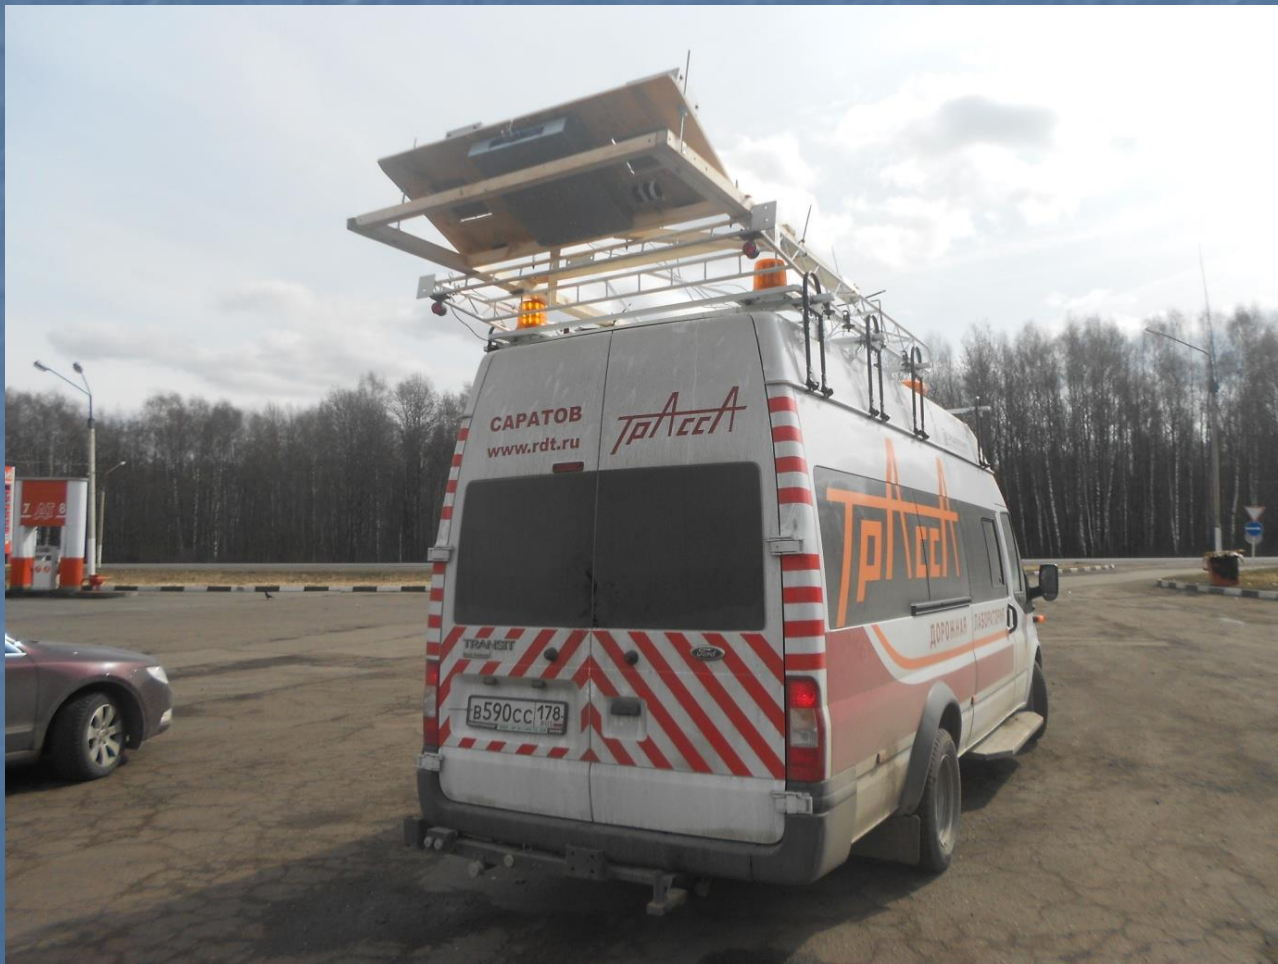
The results of radiometric sensing of the road surface of the Moscow-Minsk highway from 200 to 250 kilometers with the construction of maps of subsurface moisture content, made in April - July 2014.

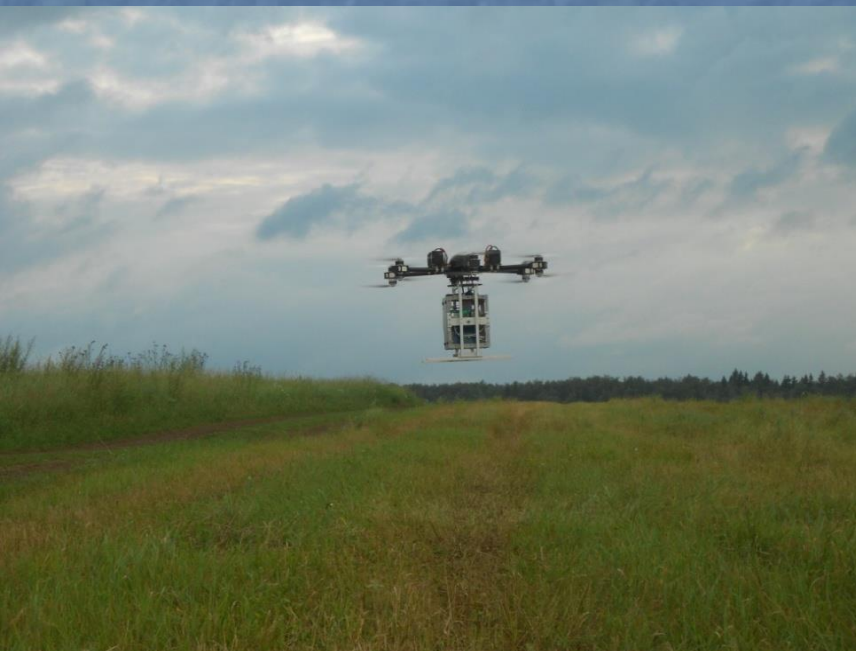
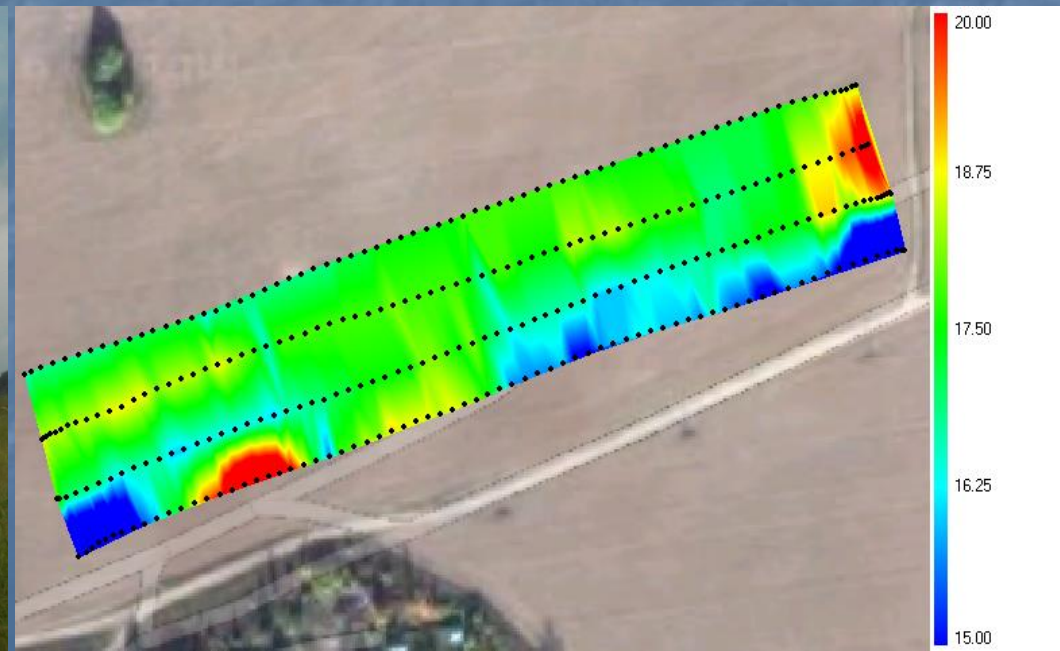
A full-scale experiment to measure soil moisture in a layer up to ten centimeters and soil surface temperature using a microwave radiometer placed on board an unmanned aerial vehicle, made in July 2016.

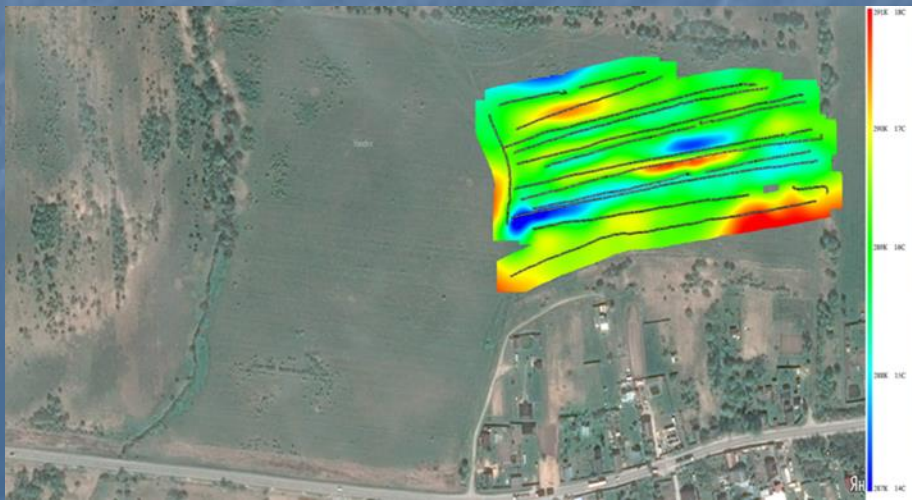
Soil temperature

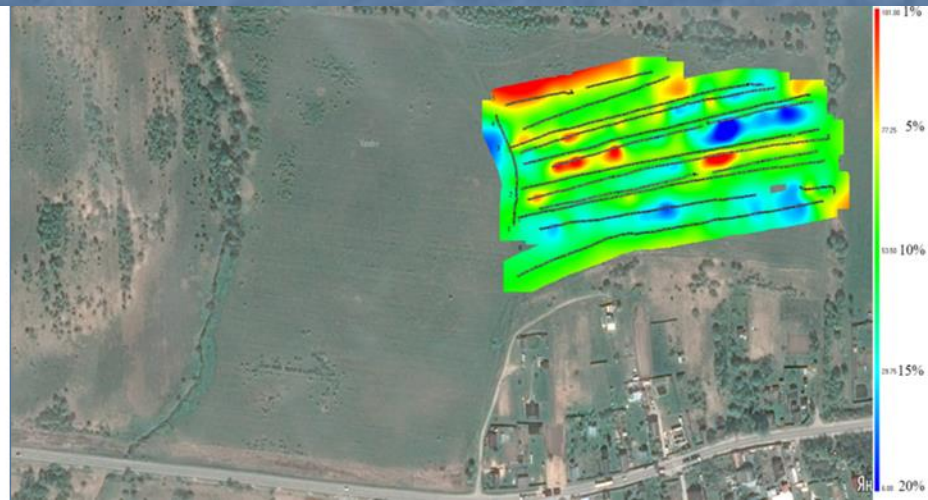
Soil moisture
